**EPRI Feedwater Heater Technology Seminar and Conference**  
**July 27-29, 2010 Dallas, Texas**

**LP Feedwater Heater Repaired to Guarantee Reliability**

**Abstract:**

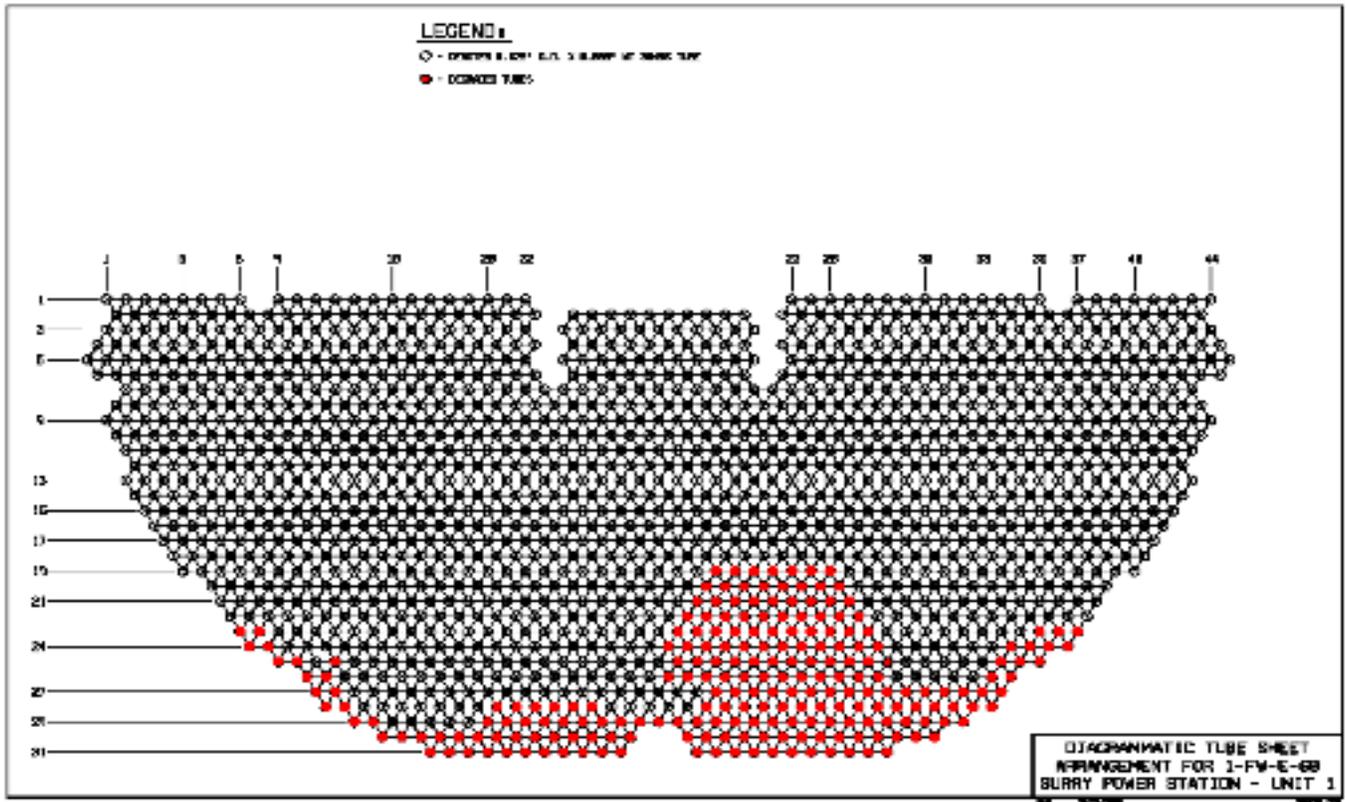
**Figure 1. Tube Sheet Map Showing Location of the Damaged Tubes:**

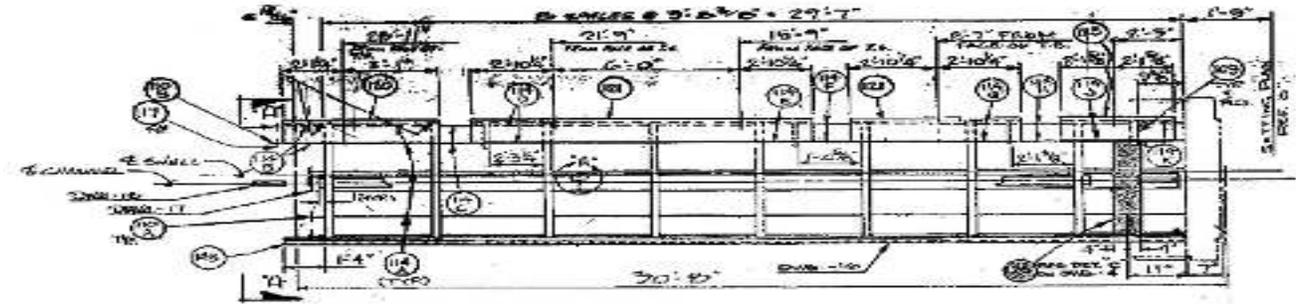
**Figure 2: The anti-flash baffle side view located between the water level and tubes.**

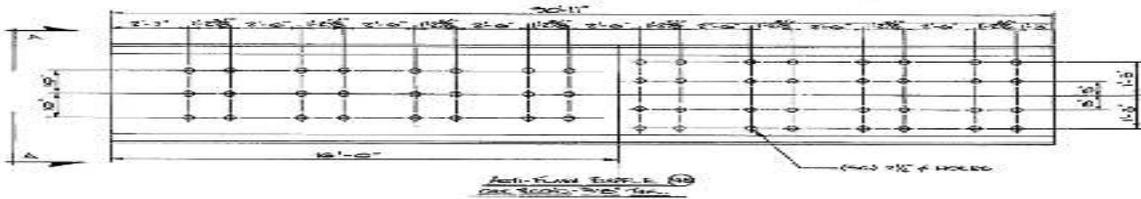
**Figure 3: The anti-flash baffle top view drawing showing 2 1/4" hole location:**

The first recommendation is to increase the size of the holes in the anti-baffle from 2 1/4" to 3" OD. The turbine manufacturer was notified of the increase area available to flash.

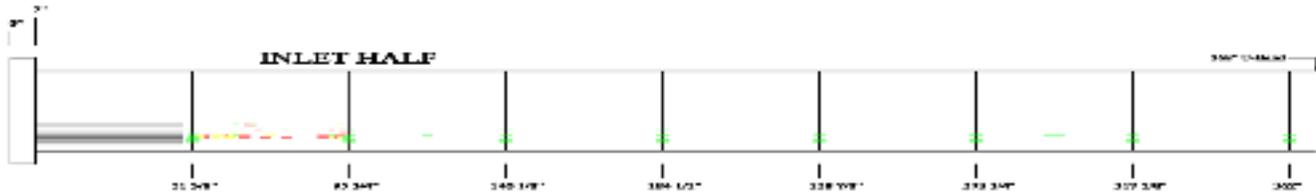
The location of the tube defects along the length of the tubes were documented in the eddy current report and on the attached bundle drawing. Figure 5 Tube defects along the length of the tubes shows most defects near tube sheet.

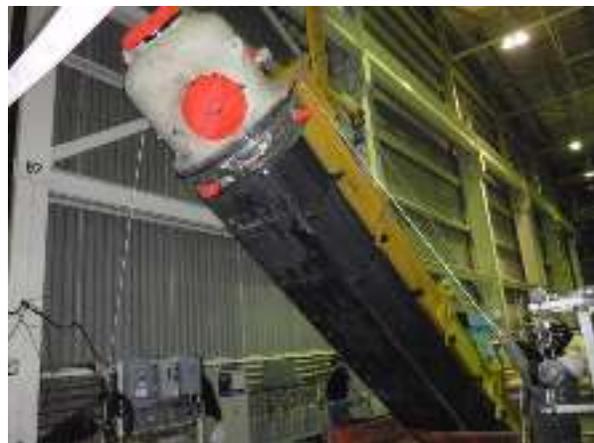
Fig 7. Condenser neck heater prior to removal.

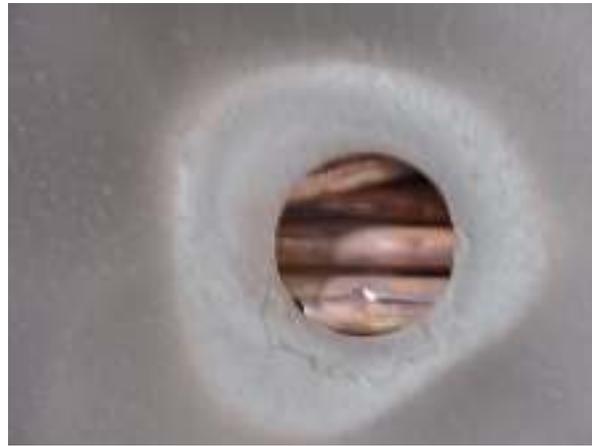
During the past four years the plant experienced a number of turbine trips which caused the turbine extraction line to the 6<sup>th</sup> point condenser neck LP Feedwater Heater to go from 6.9 positive pressure to a vacuum. When this occurred condensate in the bottom of the LP FWH shell would flash resulting in high velocity steam and water moving vertically through the anti-flash baffle and past the tubes in the FWH bundle. The location of the anti-flash baffle only 1/4" below the bottom row of tubes and the 2 1/4" OD baffle holes in the anti-flash baffle contributed to high velocity water vapor and steam attacking the 5/8" OD X 20 BWG SA-688-304 stainless steel U-tubes causing erosion and vibration damage to the tubes resulting in tube leaks which needed to be plugged. With additional turbine trips the tube damage continued to work it's way up the bundle until in April 2009 a total of 232 tubes were plugged and the damage worked it's way to the eleventh (11) row from the anti-flash baffle.

**Fig. 9. Erosion at flash baffle holes.**

3. Remove parts of pass partition to gain full access to the tube sheet.
4. Eddy current to verify tube damage and determine tubes to be replaced.
5. All 2-1/4" flash baffle plate holes to be increased to 3" in order to reduce flash flow velocity.

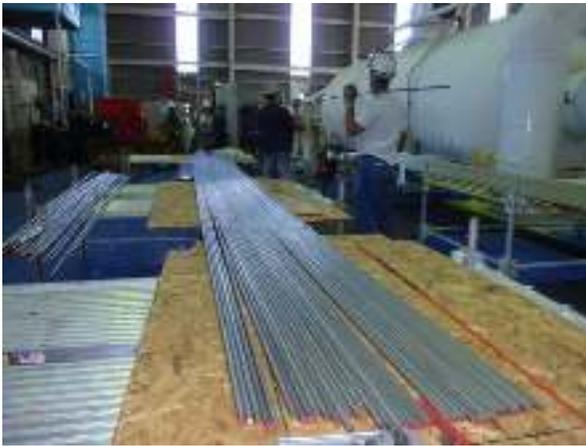
**Fig. 14. Installing new 304 SS U-tubes.**

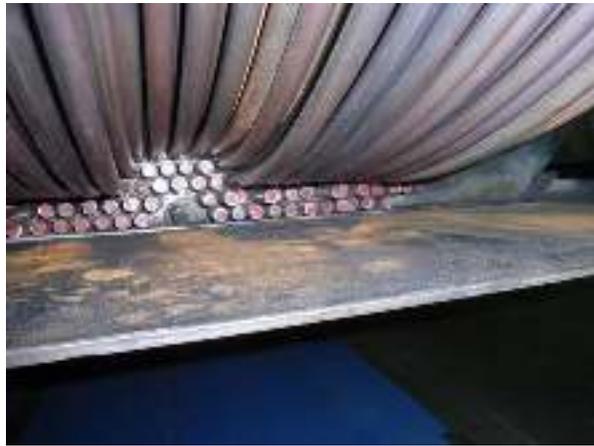
Fig. 15. 5/8" OD SS bars to protect new tubes.      Fig. 16. Welded bar stock to last tube support.

The second recommendation was to protect the new replacement tubes with 5/8" OD stainless steel bars in place of the first two rows of tubes to slow the flash velocity and protect the new 5/8" X 20 BWG 304 stainless U-tubes installed in rows three to eleven. The total number of tubes removed from service would be 107 of the total 1,520 U-tubes in the heater or seven (7%) of the total number of tubes.

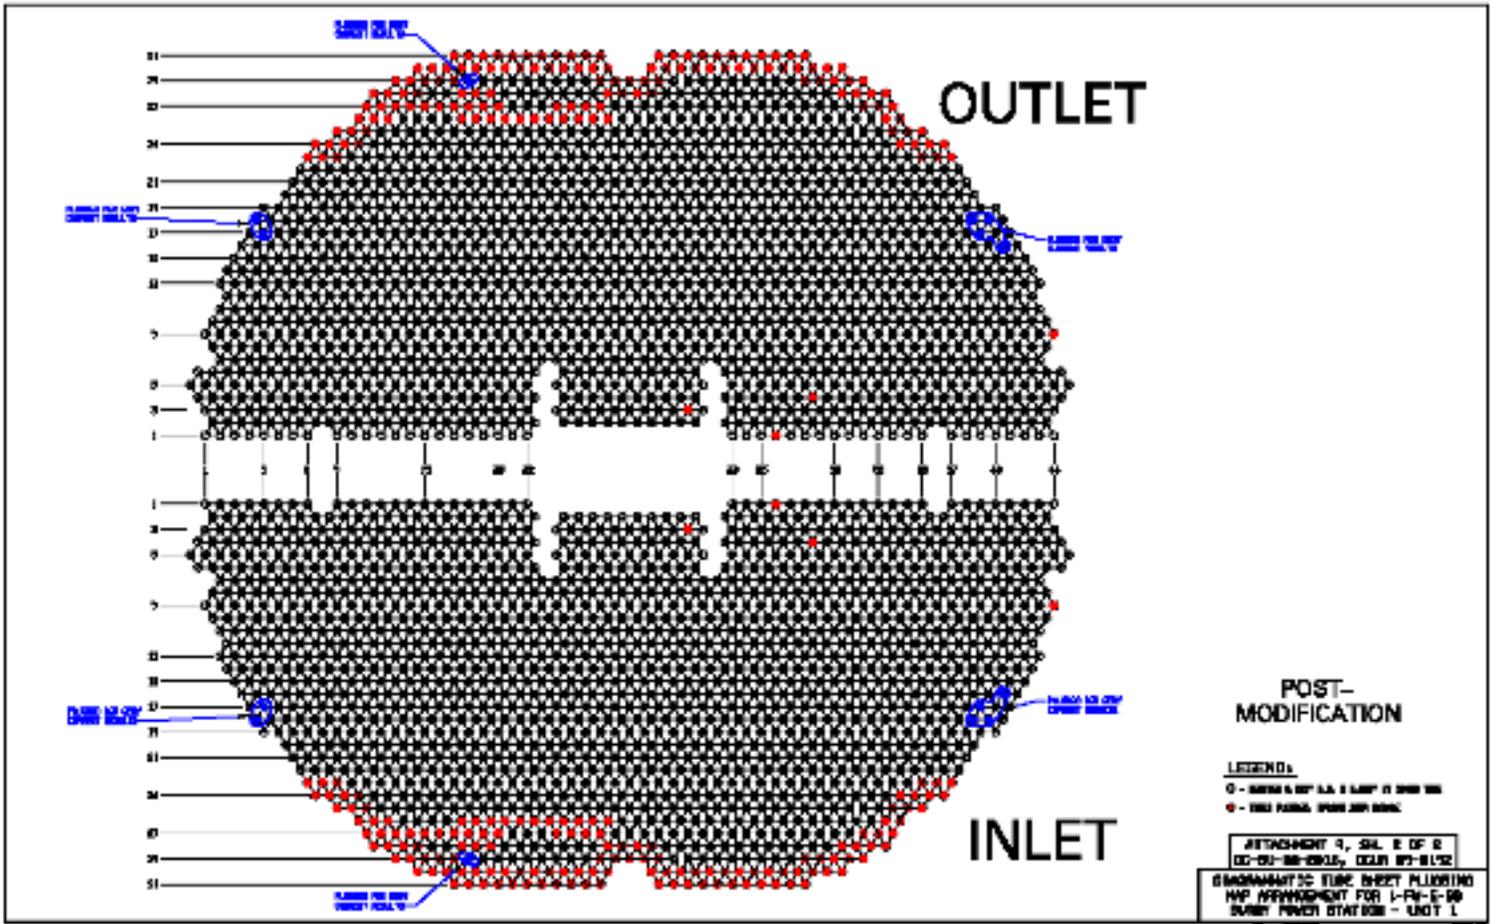
Figure 17. 107 tubes staked and plugged to protect the new and existing tubes from future damage.

15. Install 107 full length stainless steel solid rods in the bottom three rows and on the sides to protect the new and existing tubes. The top half of the U-tubes to be left out and plugged to the tube sheet.

16. Install (214) 5/8" OD explosively welded or fusion welded thimble plugs to permanently seal the 107 U-tubes to be permanently removed.
17. Clean and debur the tube support plate holes and the flash baffle plate.
