# **EPRI Feedwater Heater Technology Seminar and Conference**

## **Rebuilding IP Feedwater Heaters Improves Performance and Saves Money**

### **Abstract:**

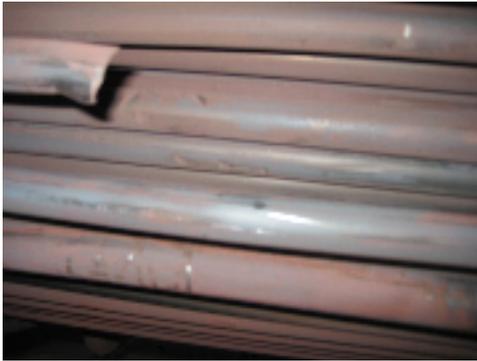
The de-superheating (DSH) zone was originally designed too large. This resulted in saturated water exiting the DSH zone at excessive velocities causing tube erosion and tube vibration in the zone. The eddy current test report documented this OD tube erosion and vibration damage from localized excessive steam velocity and steam impingement. One of the two IP feedwater heaters had tube failures from flashing condensate in the sub-cooling zone close to the SCZ end plate. The end plates for both heaters were replaced with 3" thick end plates with tight tube hole tolerance.

**Figure 3. DSH Tube Vibration Damage**

1. Relocated steam inlet to the bypass nozzle to allow steam flow reduction in DSH.
2. DSH Re-designed steam flow to reduce steam flow velocity to eliminate tube vibration.
3. Reduced the overall size of the DSH to eliminate condensing and Wet Walls
4. Replace damaged SCZ end plates using 3” thick plates with tight tube hole tolerance.

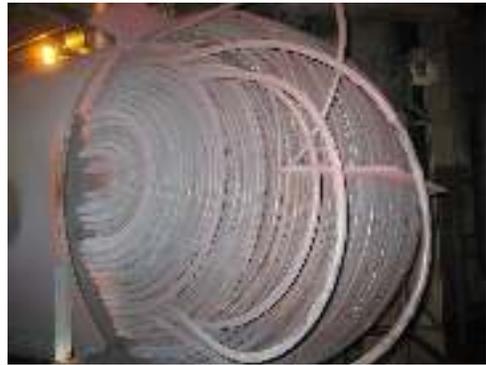
**Figure 4. Severed tubes in shell dome.**

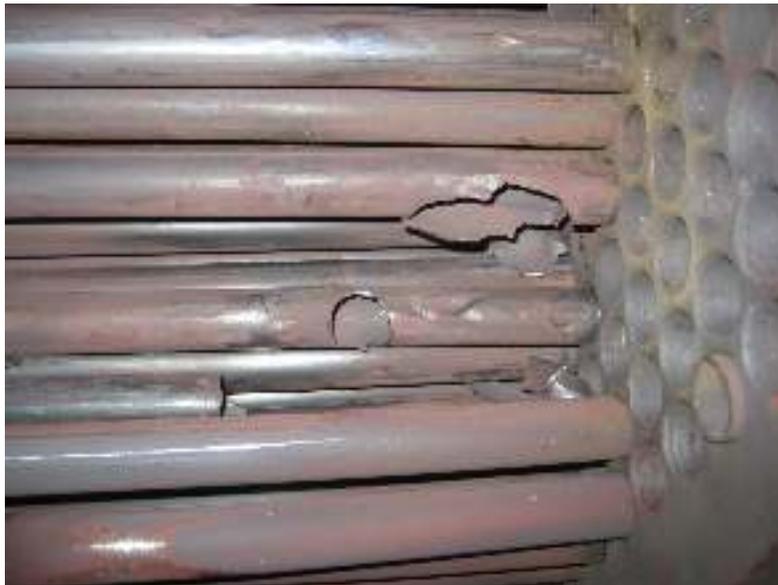
**Figure 5. Condensate flashing in SCZ at End Plate**

20. Align all the zones and install a new 3” thick endplate in each heater.

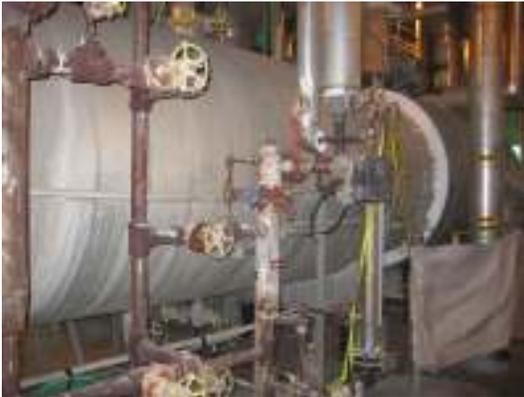
**Figure 7. Only 5' of insulation removed for shell cut.**

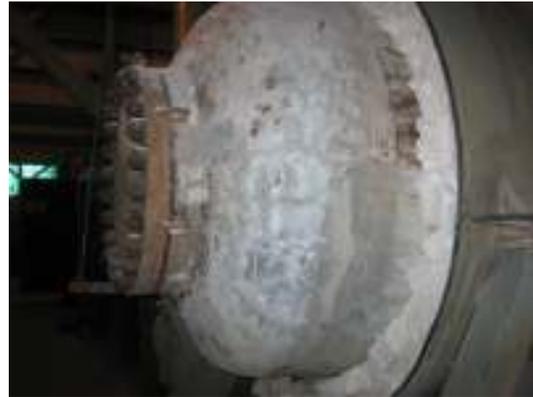
**Figure 8. Removed head insulation.**

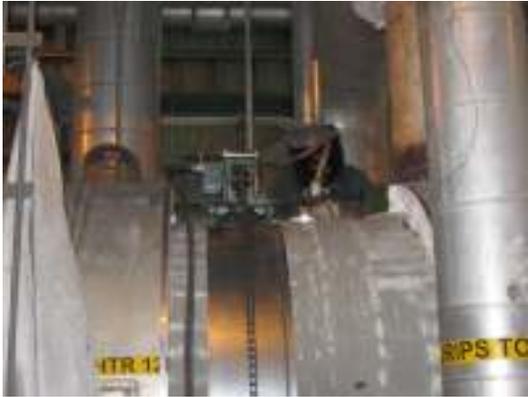
**Figure 9. Cutting shell with track cutter    Figure 10. Cut head with rotary torch cutter**

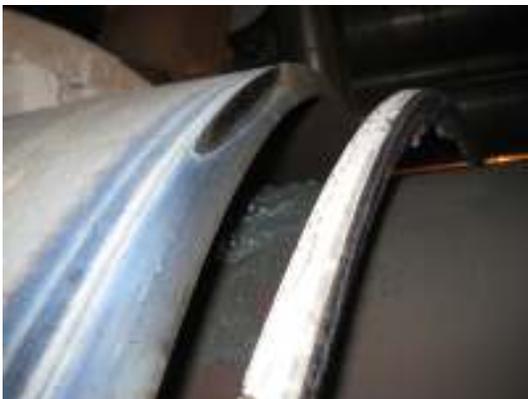
**Figure 11. Shell cut prepped for re-welding.    Figure 12. Head Cut provides weld prep.**

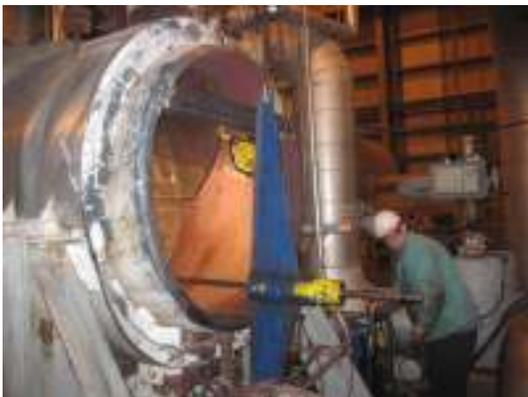
**Figure 13. Hydraulic tube stub removal.**

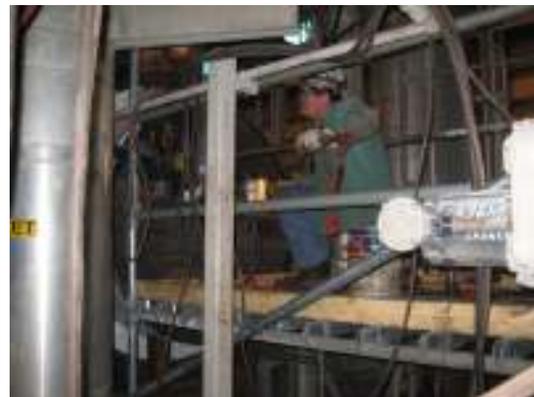
**Figure 14. Pulling stubs from back face.**

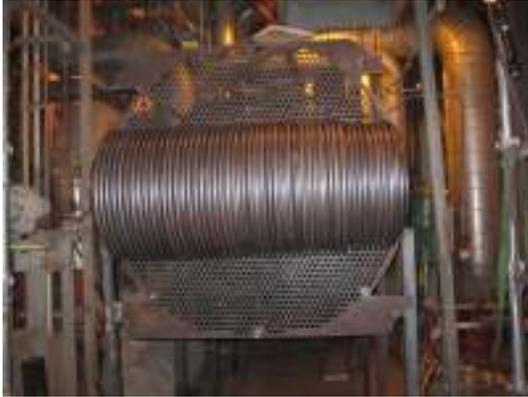
**Figure 15. New tubes in rebuilt cage**

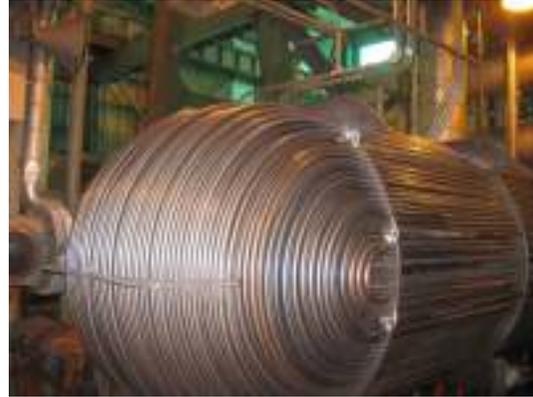
**Figure 16. New bundle ready for shell**
