EPRI Condenser Technology Conference
August 3-4, 2011 Chicago, Illinois

Testing and Installing Repair Sleeves will Improve Reliability, Performance and Extend Condenser Life.

Daniel D. Bina
American Power Services Inc.
2788 Circleport Drive Erlanger, Ky. 41018
danbina@1aps.com

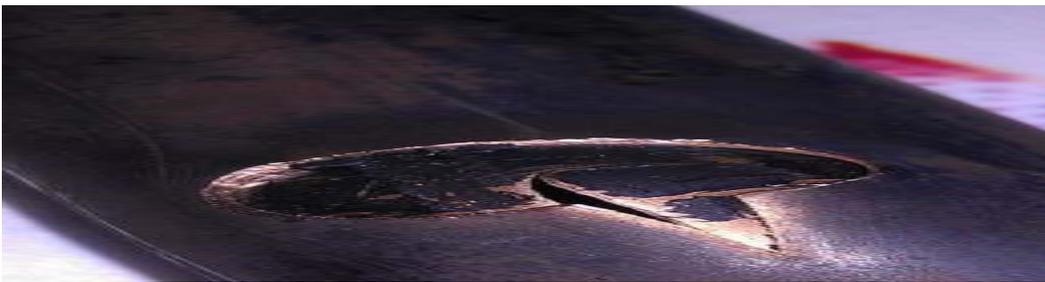
Condenser sleeve: This 7/8" OD X .049" wall parent tube with a hole, sealed with a 3/4" OD X .035 wall sleeve. A Hydro Test starting at 100 psi to 4,000 psi provided 100% leak free seal. At 4,500 psi the sleeve material yielded and bursed the .035" wall sleeve through the parent tube hole. The hydro tests held for days between 100 to 4000 psi without a drip before building pressure to burst.

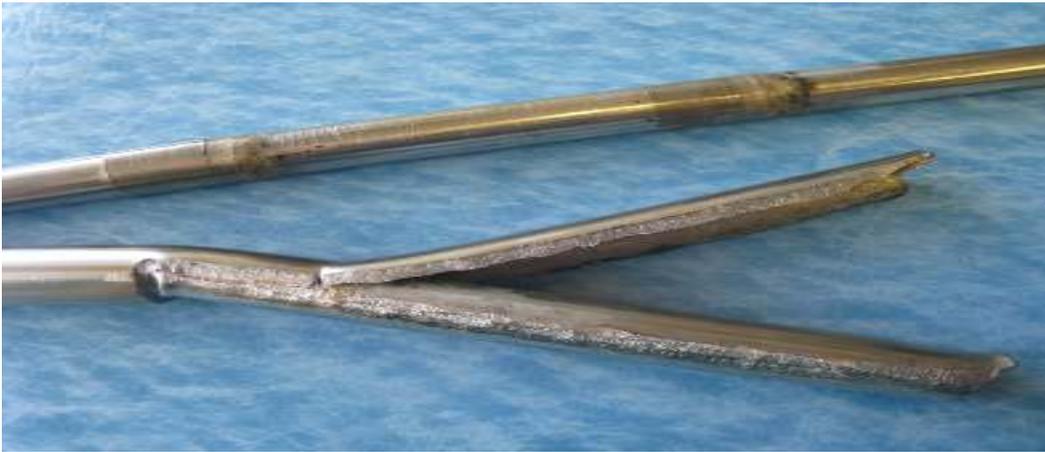
Feedwater heater sleeve: This 5/8" OD X .083" wall parent tube with a through wall hole was sealed with a .430" OD X .035" wall sleeve. A Hydro Test started at 500 psi to 10,000 psi provided 100% leak free seal. A hydraulic mechanical strength test to pull the parent tube and sleeve stretched and then broke the sleeve in two. The brazed joint remained as a leak free seal. The brazed joint was tested by mechanically pulling the parent tube away from the sleeve as shown above. The strength of the brazed joints was not effected.

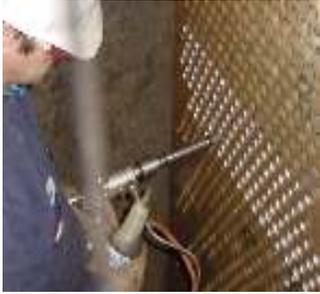
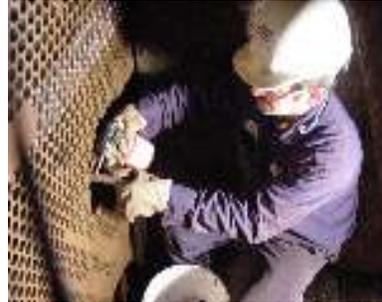
documented on nearly all Inlet erosion reduced the wall of the tube three inches from the face of the tube sheet to 30% of the tube wall and at the same time ammonia grooving on the back side of the tube sheet eroded the OD of the parent tube. There was also ID erosion in 1/4th of the outlet tubes in one water box. The remainder of the tubes were in excellent condition with very few tube defects.

Hydraulically Expanding 6" long sleeves to seal leaking tubes at the inlet and outlet tube sheets.

The plant decided to extend the life of this condenser tubes for at least 2 years by installing 20,000+, SB-111, Alloy 706, 90/10 Cu/Ni .910" OD X .028"AW 6' long inserts from the tube sheet face 6 inches down the length of the tubes. The length of the sleeve (insert) would prevent additional inlet erosion and allow the damaged tube behind the tube sheet to be repaired at the same time. The outage time to complete the cleaning and installation of over 20,000 sleeves was 10 days working (2) 12 hour shifts.

1" long collars were also used between the insert and the eroded parent tube ID at the tube sheet to strengthen the tube joints and help prevent cracking of the very thin parent tubes with severe inlet erosion. All (550) tubes previously plugged were opened, eddy current tested, cleaned eight inches down the length of the tubes and then 6" long inserts some with collars were installed, hydraulically expanded 6", hard rolled at the tube sheet and the far end of the sleeve was feathered into the parent tube to prevent the development of condensate erosion at the end of the sleeve. The product "Loctite" was used between the insert and the parent tube on the 7,000 inserts installed in the tube outlets to prevent the possibility of an insert coming lose. The sleeve installation took 216 elapsed time hours, 9 days working (2) 12 hour shifts, (1 day early).

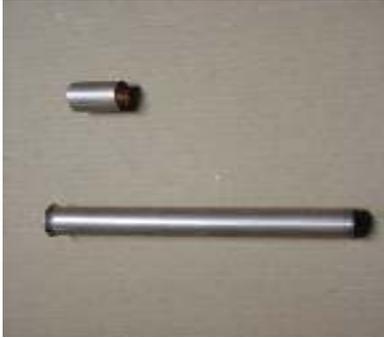
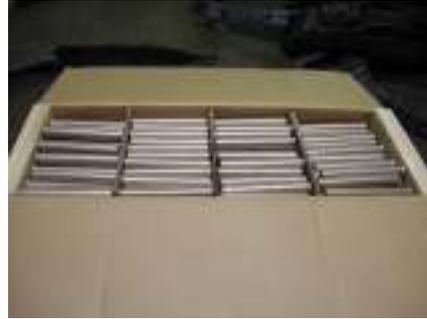
20,000 6" X .910 OD X .035" wall 90/10 Cu/Ni tube sleeves installed in 9 days.

The project included removing 1,100 tube plugs (550 tubes) and install (16,318) 6" long sleeves to prevent continued inlet erosion and reinforce the tube OD metal loss ammonia grooving damage also at the tube inlet water. (4,000) 6" long sleeves were also installed in the outlet water box tubes having the highest ID erosion (50 to 70% IDML). The tube ID's were cleaned and 20,000 sleeves were installed in (18) 12 hour shifts or 9 days. After the installation a standing hydro revealed only 8 tube leaks remained. 542 out of the 550 previously plugged tubes were back in service (98.5%). The \$2 million + retubing project was postponed and the condenser ran reliably with an improved thermal performance for 6 years before it was retubed in 2007.
