Tube Sleeves Breath Life into Failing **HP Feedwater Heaters**

Abstract

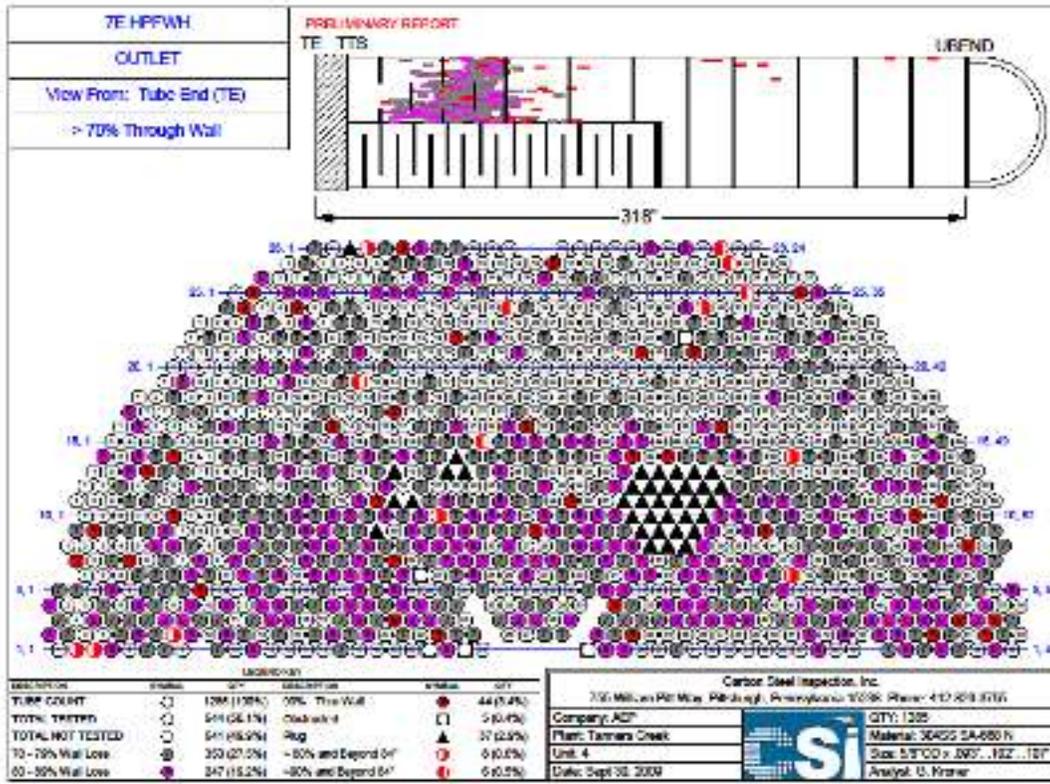
Figure 3. 7E Heater Eddy Current Results showing over 320 tubes with stress cracks over 70% of the tube wall most were in the de-superheating zone within 6 feet from the tubesheet.

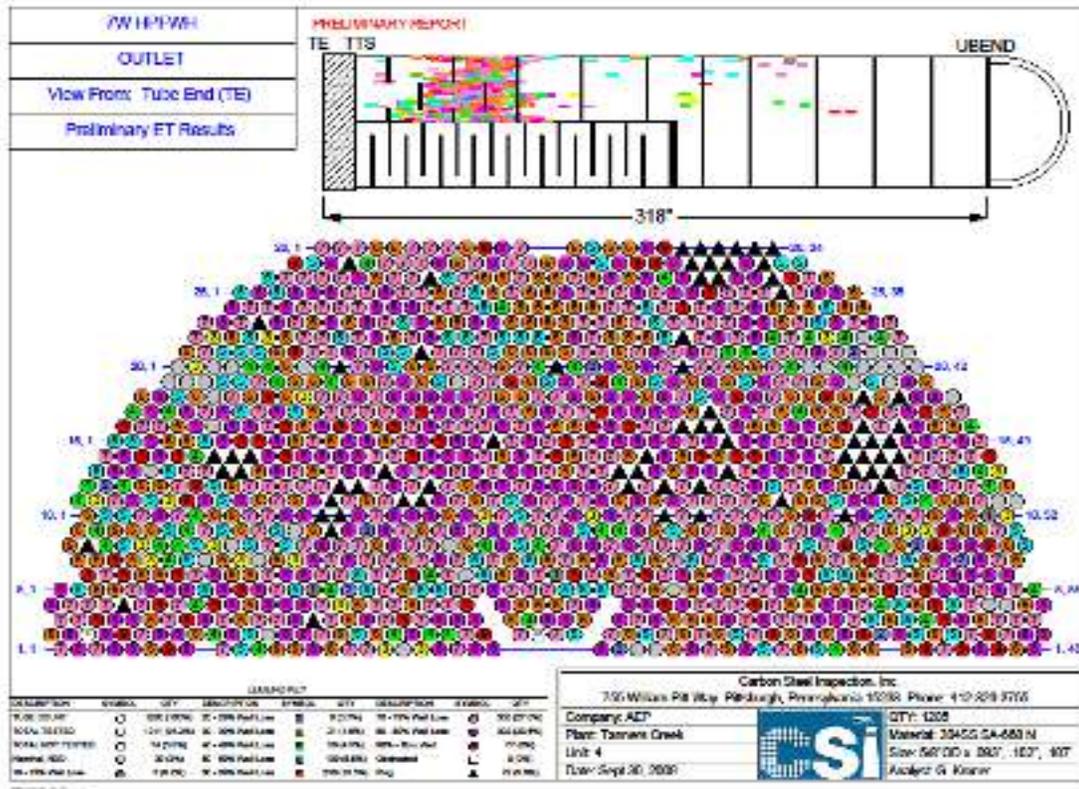
Figure 4. 7W Heater Eddy Current Results showing over 380 tubes with stress cracks over 70% of the tube wall, most were in the de-superheating zone within 6 feet from the tubesheet.

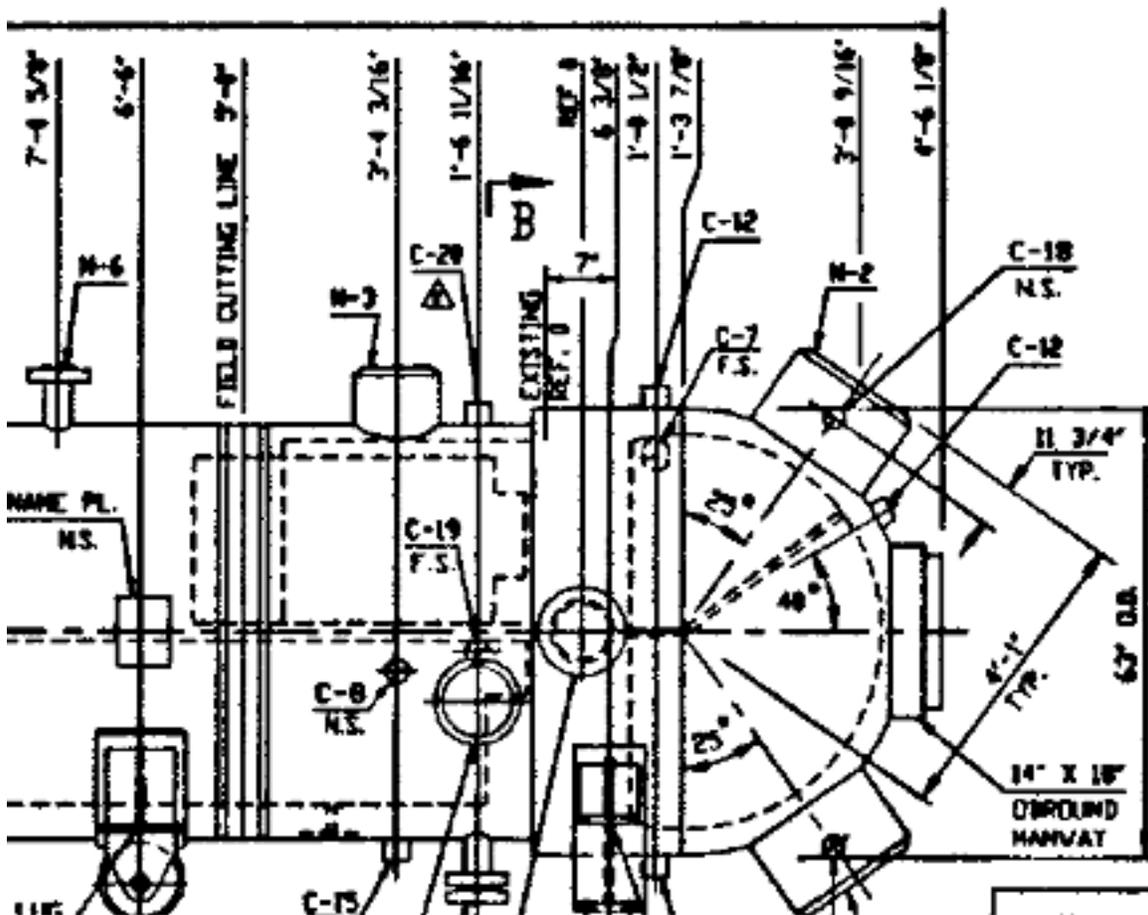
There were a number of difficulties to overcome. The heaters had small hemi-head channels which made it difficult to install seven (7') foot long 304 stainless steel sleeves. The room in the hemi-head was 8 to 30" deep X 54" high at the tubesheet with the pass partition plate removed.

Figure 5. Hemi-head with 14"X18" man way and a 8 to 30" deep X 54" high work space to install (613) 7'long SS tube sleeves.

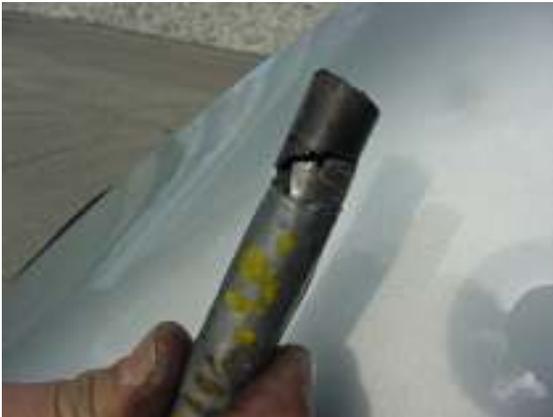
Figure 6. 5/8" OD X .108"W Tube Crack

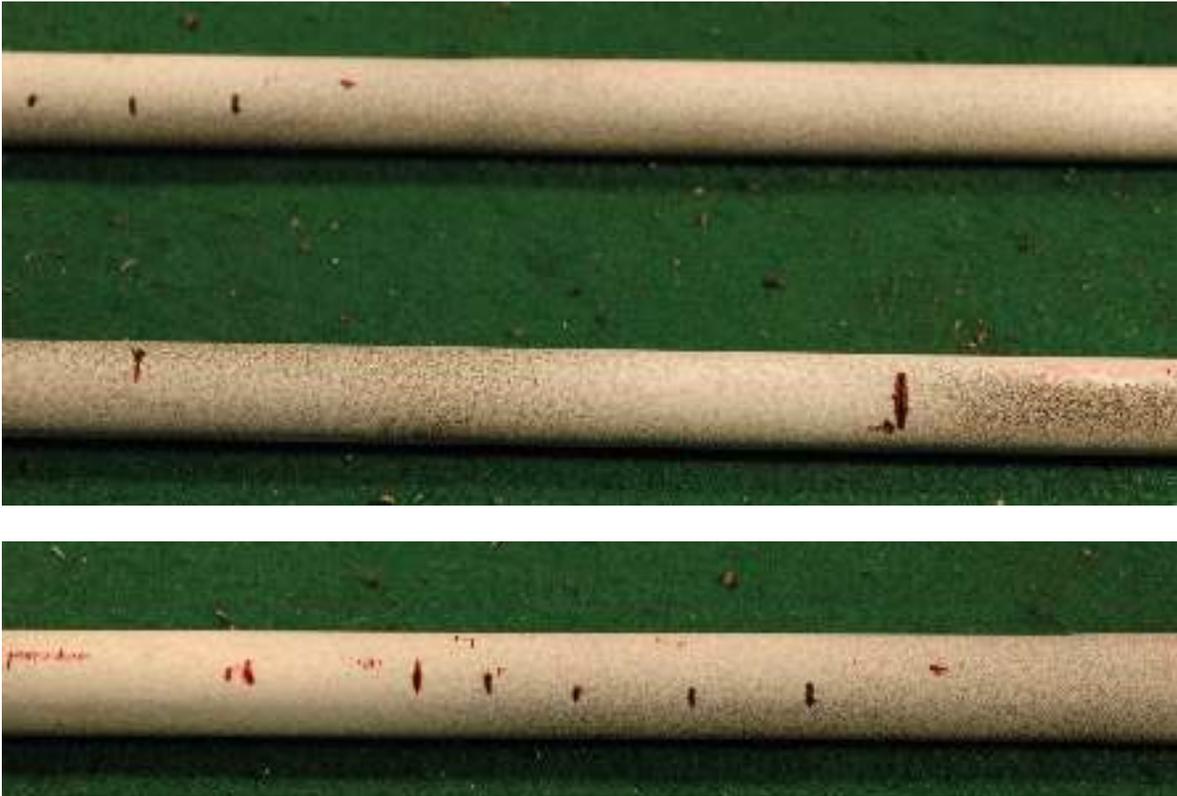
Three pieces of HP heater tubing from the 7E heater de-superheating zone were sent to AEP's laboratory for metallurgical failure analysis. The pieces analyzed were all part of the same section of tube which was reported as not containing an actual failure but did have eddy current indications of 0.080" wall loss or greater. The three pieces were 21", 9 1/2" and 4" in lengths. Examined under the stereomicroscope and used visible dye penetrant to identify surface-breaking defects in the tube. The photographs attached below show the visible dye penetrant indications. The indications detected were uniformly circumferential cracks.

Figure 8. Dye penetrant indications in tube samples.

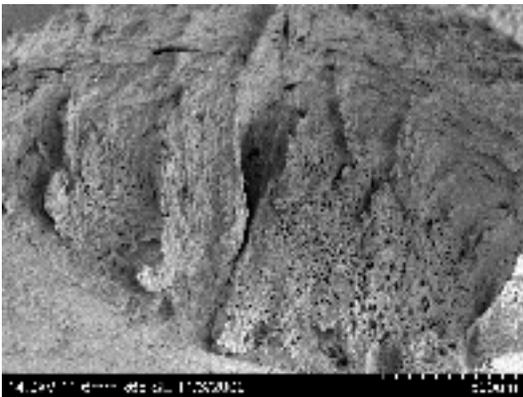
Figure 9. Thumbnail-shaped surface crack.

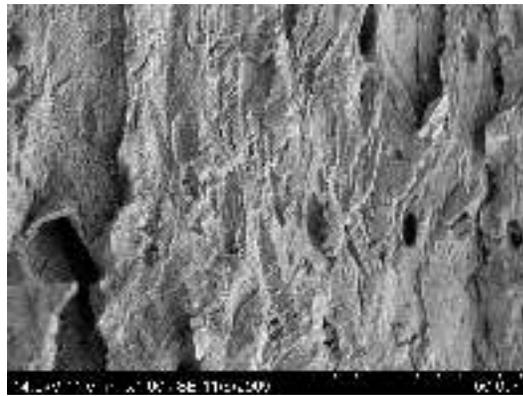
Figure 10. Transgranular crack texture with some brinelling damage present.

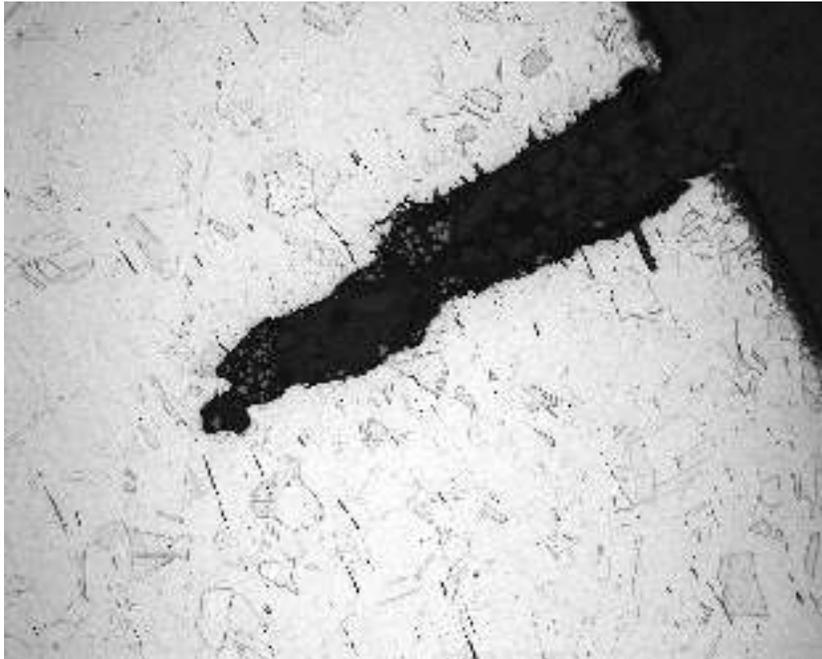
Several metallographic sections were prepared, polished on longitudinal faces normal to the circumferential crack pattern. Examination of these metallographic specimens confirmed that the cracks were blunt-tipped, transgranular with very little crack branching. This type of crack morphology and the number of cracks present suggests thermal fatigue cracking as a likely cause of the cracks.

Figure 11. Crosssection of circumferential crack, transgranular, non-branched and blunt-tipped. 400X Oxalic acid etch.

Based on the evidence in these samples, the cracking present appears to be the result of thermal fatigue initiating circumferentially possibly in response to bending stresses present in the installation in the heater. The residual hoop stress, when added to the service stresses should be sufficient to cause longitudinal failures from stress corrosion cracking. Since this does not seem to be the cause of failure in this sample, it would appear that (1) sufficient tensile stress is not present to cause longitudinal stress corrosion crack failures, (2) there was insufficient corrodent present to promote longitudinal stress corrosion crack failures or (3) there was an unknown cyclic loading present that caused the longitudinal stress in the tube to become the principle stress relative to this failure mechanism.
